**Flood Control Project Maintenance  
Levee Inspections**

**Maintenance Issue Types Only, Levee Inspection Report By Mile - Fall 2019**

**Sutter Maintenance Yard Maintenance Area 0005**

Waterway	Bank	Unit Miles	Inspection Start/End	Inspector
Unit No. 01 Butte Creek	Left	15.08	10/23/2019 10/23/2019	Makar Sokol

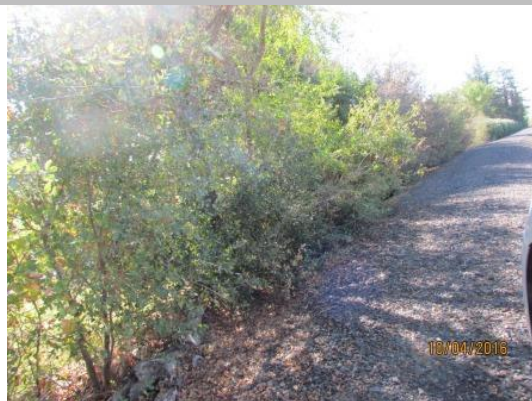
Photo 1 of 1 : FA\_2019\_MA0005\_196\_32\_20190822\_00012.jpg

View of the trees along the landside toe blocking visibility.

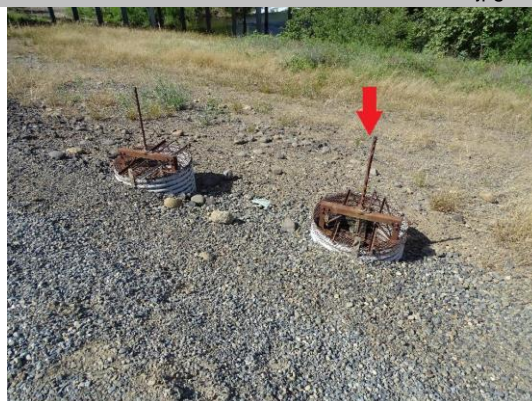
Photo 1 of 3 : UCIP\_FA\_2019\_54141\_79700.jpg

CMP riser and slide gate on WS shoulder

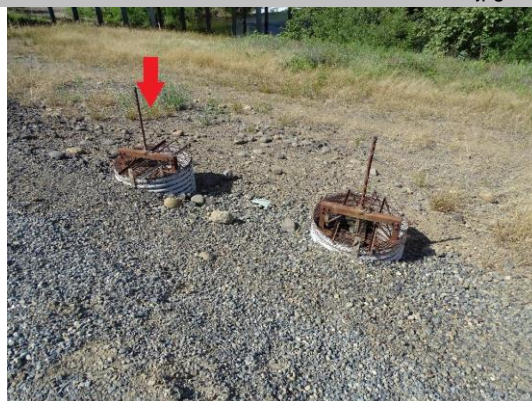
Photo 1 of 3 : UCIP\_FA\_2019\_54142\_79701.jpg

CMP riser and slide gate on WS shoulder

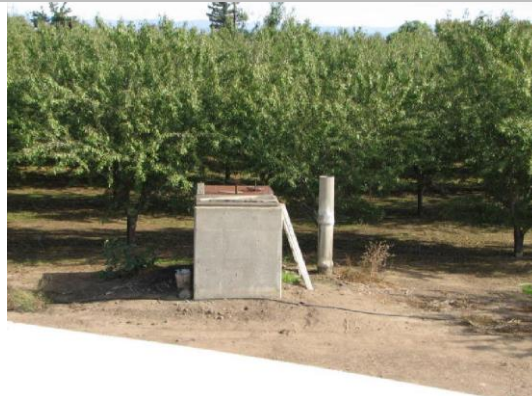
Photo 3 of 3 : UCIP\_FA\_2019\_54142\_67932.jpg

Concrete distribution box on LS, 40-feet from LS toe

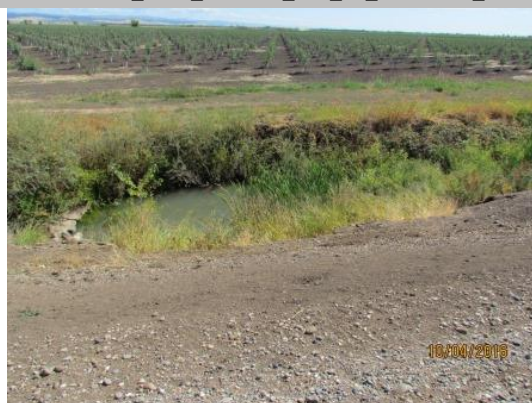
Photo 2 of 2 : FA\_2019\_MA0005\_196\_56\_20190822\_00028.jpg

LM Start	5.81	Rating **	U	Issue No.	56
LM End	5.81	Issue Type +	Ma	Location *	LS
Category	Earthen Levee			GPS Latitude/Longitude	
				Start	End
Item	Erosion / Bank Caving			39.621261 °	39.621261 °
				-121.773973 °	-121.773973 °
DWR ID	DWR_MA0005_01_f_2016_56				
Comment Code					
E2 : Schedule repair of erosion site prior to the next inspection.					
Inspector Comment

Another view of the landside toe erosion.

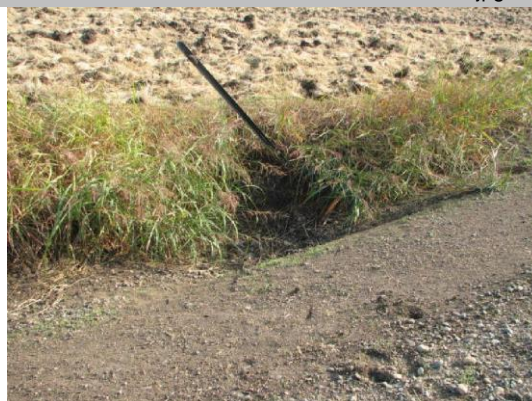
Photo 1 of 2 : UCIP\_FA\_2019\_51970\_67970.jpg

Headwall at LS toe.

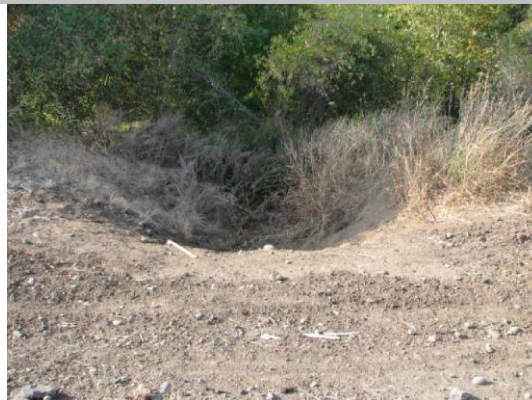
Photo 1 of 3 : UCIP\_FA\_2019\_51972\_67973.jpg

Outlet at WS toe.

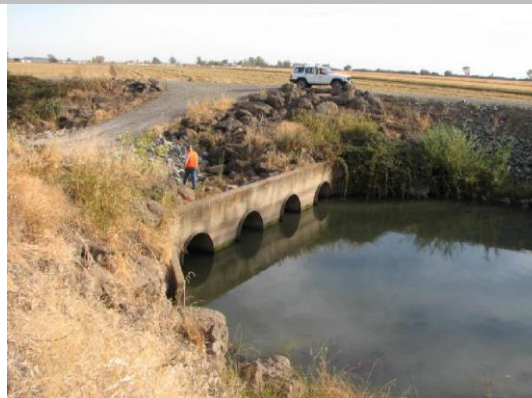
Photo 1 of 2 : UCIP\_FA\_2019\_51976\_67979.jpg

WS of pipe crossing

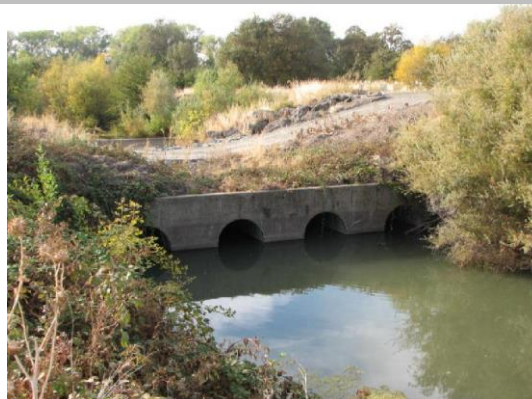
Photo 2 of 2 : UCIP\_FA\_2019\_51976\_67978.jpg

LS of pipe crossing.

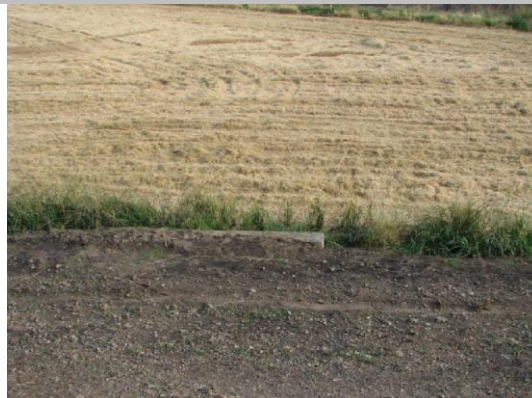
Photo 1 of 2 : UCIP\_FA\_2019\_51982\_67991.jpg

Comment Code					
Inspector Comment					
DS_ID:1635 FS_ID:51982 EP_NO: N/A Repair Type: Non-Urgent Crossing Status: Found UCIP Comments: 5/16/2017 Abandoned- needs to be done so properly. (DWR Sutter Yard- AFreitag)11/15/2016 Abandoned. (DWR Sutter Yard- AFreitag)5/11/2016 Abandoned crossing.8/4/2015 Abandoned pipe. Casey Wilder has started the steps to have the pipe properly abandoned and removed from the levee.12/8/2014 Same as last inspection.6/11/2014 Same as last inspection.11/19/2013 Same as last inspection.5/29/2013 Same as last inspection.10/30/2012 Pipe buried on both sides of levee. FIELD_STRUCT_DESC: *ABANDONED* 30-inch corrugated metal drainage pipe through the levee, 12.2 feet below the crown. Flap gate on the waterside (WS) end. [Additional Reference(s): DWR Levee Log, 1990 (HLM 10.99). USACE Sacramento O&M Manual, Unit 515 - Upper Butte Creek - Part No. 1, April 1955, (Station 748+53). USACE As-Built Drawing No. 50-4-2637, Exhibit B, Sheet 4, April 1950]. FS Date: 5/31/2017 2:18:08 PM

Concrete headwall at LS toe.

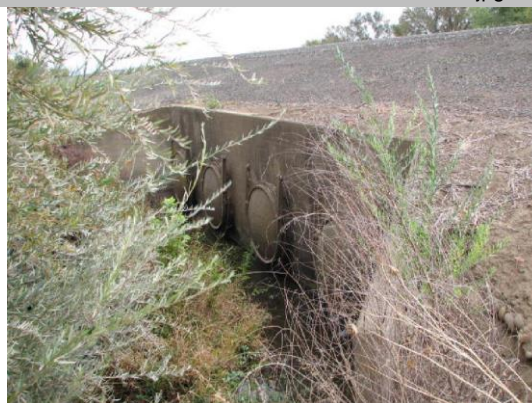
Photo 1 of 2 : UCIP\_FA\_2019\_51990\_68007.jpg

WS headwall and flap gates at WS toe.

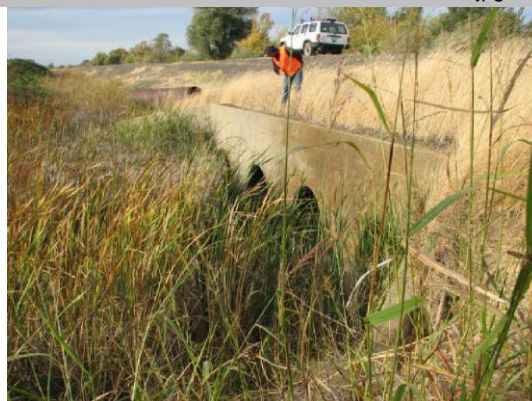
Photo 2 of 2 : UCIP\_FA\_2019\_51990\_68006.jpg

LS intake headwall.

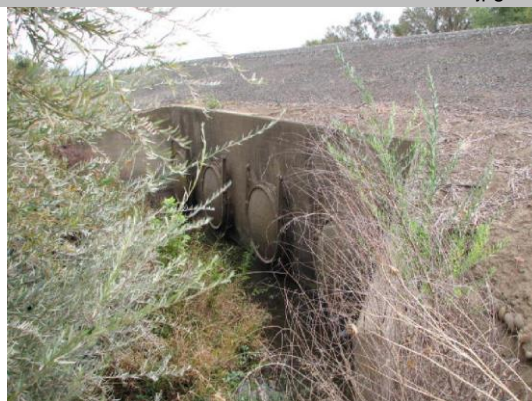
Photo 1 of 2 : UCIP\_FA\_2019\_51991\_68009.jpg

Headwall and flap gates at WS toe.

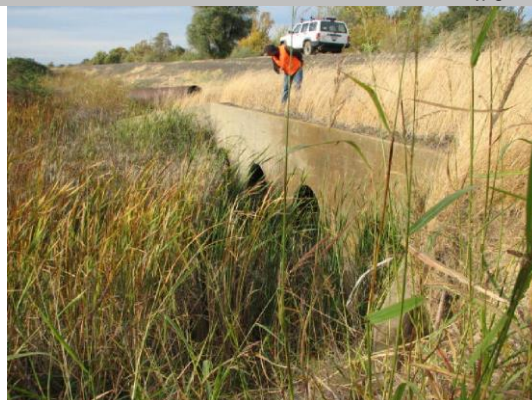
Photo 2 of 2 : UCIP\_FA\_2019\_51991\_68008.jpg

Headwall at LS toe.

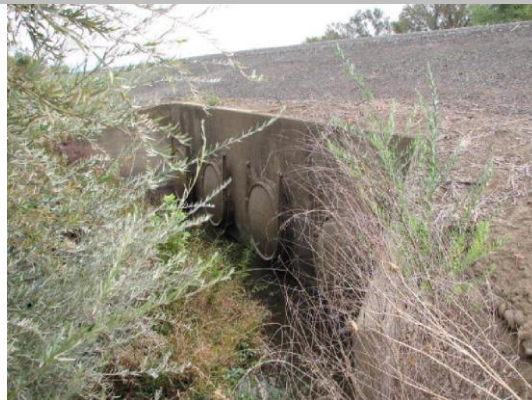
Photo 1 of 2 : UCIP\_FA\_2019\_51993\_68013.jpg

Headwall and flap gates at WS toe.

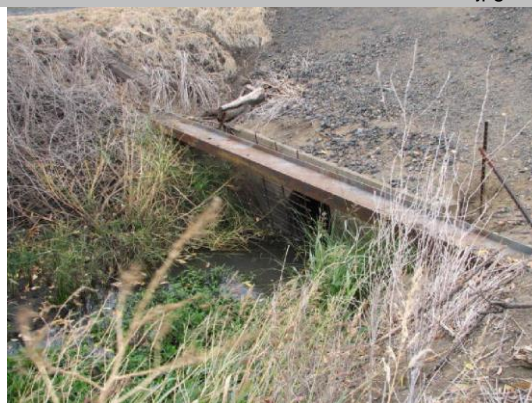
Photo 1 of 3 : UCIP\_FA\_2019\_51999\_68033.jpg

Comment Code					
Inspector Comment					
DS_ID:1639 FS_ID:51999 EP_NO: N/A Repair Type: Non-Urgent Crossing Status: Found UCIP Comments: 5/16/2017 Soil still eroded away from the WS wing walls. Pipe has been selected to be internally cleaned and inspected as part of the DMP project. (DWR Sutter Yard- AFreitag)11/15/2016 No soil supporting the WS wing walls. (DWR Sutter Yard- AFreitag)5/11/2016 Still no soil supporting the WS wing walls and apron. WS vegetation was thinner and not a problem this time.8/4/2015 No soil supporting the WS wing walls at the WS pipe end. WS pipe end is also being overgrown with vegetation and should be cleared back.6/11/2014 Same as last inspection.11/19/2013 Same as last inspection.5/29/2013 Same as last inspection.10/31/2012 Soil under Concrete wing walls on WS toe has been eroded. No soil supporting wing walls. FIELD_STRUCT_DESC: 36-inch corrugated metal drainage pipe through the levee, 13 feet below the crown. Flap gate on the waterside (WS). Concrete headwalls on the landside (LS) and the WS ends. [Additional Reference(s): DWR Levee Log, 1990 (HLM 14.66). USACE Sacramento O&M Manual 515, April 1955, (Station 978+25). USACE As-Built Drawing No. 50-4-2637, Exhibit B, Sheet 5, April 1950, (Station 978+24.95)]. FS Date: 5/31/2017 2:39:05 PM

Headwall at inlet on LS toe.

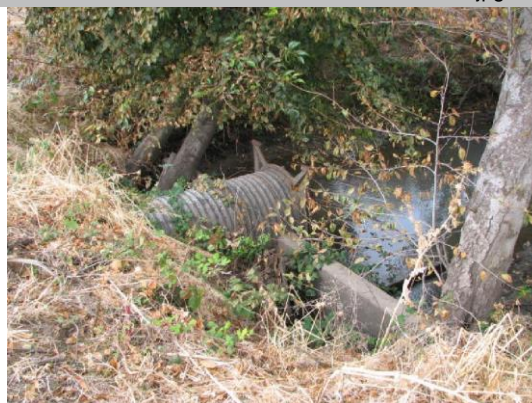
Photo 2 of 3 : UCIP\_FA\_2019\_51999\_68032.jpg

CMP pipe, flap gate, and headwall on WS toe.

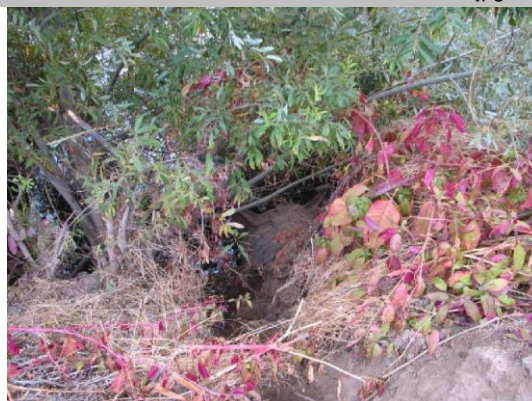
Photo 1 of 3 : UCIP\_FA\_2019\_53009\_68497.jpg

Flap gate on WS slope.

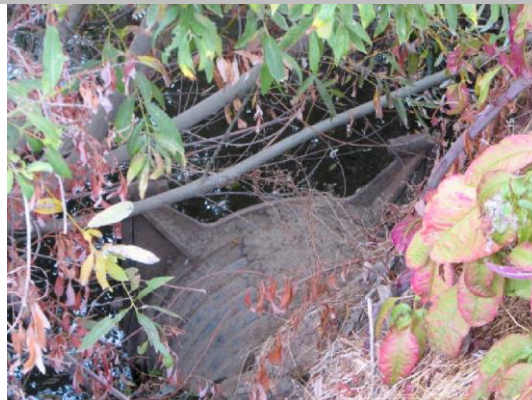
Photo 2 of 3 : UCIP\_FA\_2019\_53009\_68496.jpg

Flap gate on WS slope.

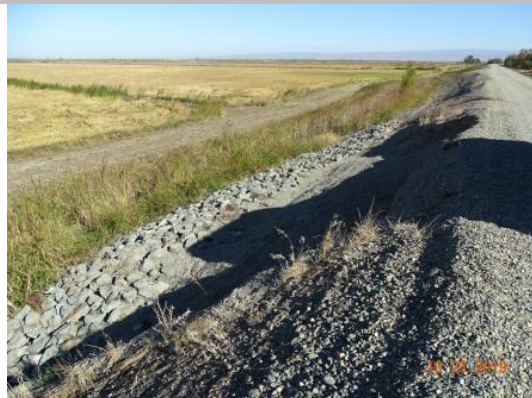
Photo 1 of 1 : FA\_2019\_MA0005\_197\_55\_20191028\_00099.jpg

LM Start	3.38	Rating **	U	Issue No.	55
LM End	3.38	Issue Type +	Ma	Location *	LS
Category	Earthen Levee			GPS Latitude/Longitude	
				Start	End
Item	Slope Stability			39.555027 °	39.555027 °
				-121.837555 °	-121.837555 °
DWR ID	DWR_MA0005_02_f_2019_55				
Comment Code					
S1 : Repair slope instability.					
Inspector Comment

View of sloughing on the landside slope. Fall 2019.

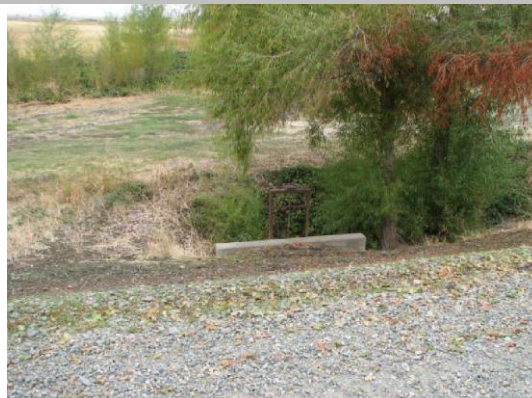
Photo 1 of 3 : UCIP\_FA\_2019\_52014\_68064.jpg

Concrete headwall and slide gate at LS toe.

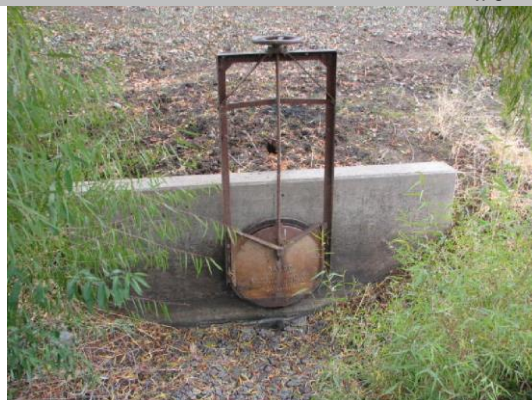
Photo 2 of 3 : UCIP\_FA\_2019\_52014\_68063.jpg

Concrete headwall and slide gate at LS toe.

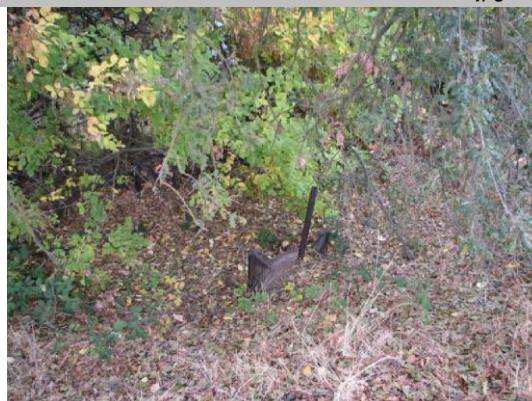
Photo 3 of 3 : UCIP\_FA\_2019\_52014\_68062.jpg

Flap gate at outlet on WS berm.

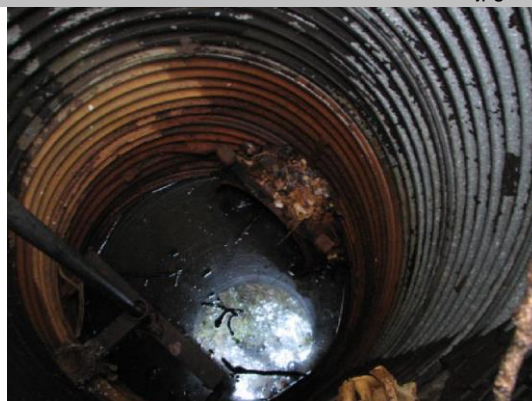
Photo 1 of 2 : UCIP\_FA\_2019\_54041\_68105.jpg

Slide gate and flap gate inside CMP riser on WS berm.

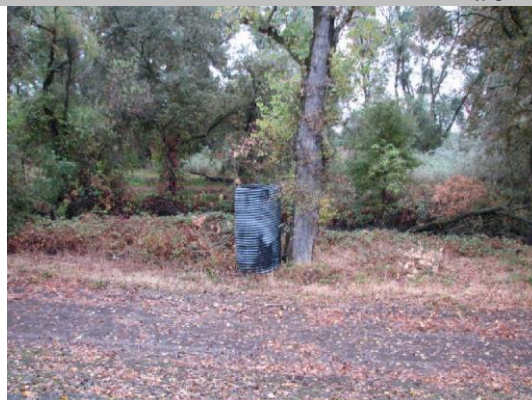
Photo 2 of 2 : UCIP\_FA\_2019\_54041\_68104.jpg

56-inch CMP riser on WS berm.

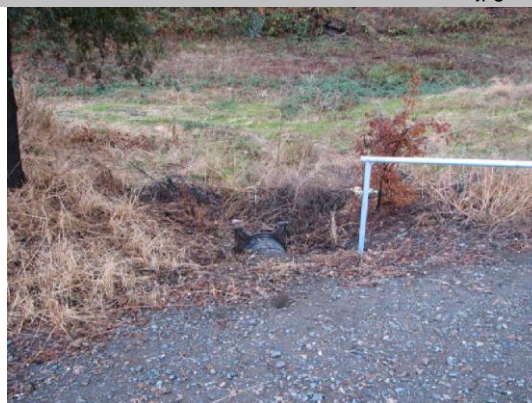
Photo 1 of 3 : UCIP\_FA\_2019\_52049\_68122.jpg

Flap gate on WS toe.

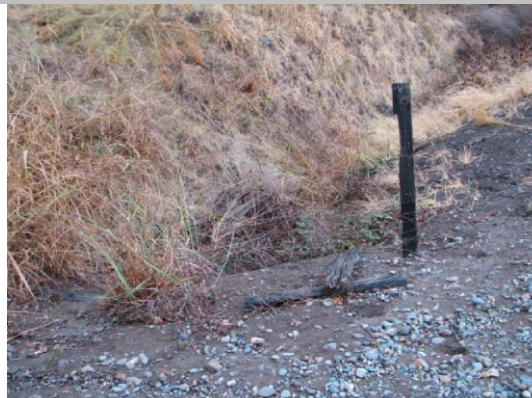
Photo 2 of 3 : UCIP\_FA\_2019\_52049\_68121.jpg

Comment Code						
Inspector Comment						
DS_ID:1654 FS_ID:52049 EP_NO: N/A Repair Type: No Action Needed Crossing Status: Found UCIP Comments: 5/18/2017 Crossing appears to be in good condition. Pipe has been selected to be internally cleaned and inspected as part of the DMP project. (DWR Sutter Yard- AFreitag)11/14/2016 Crossing appears to be in good condition. (DWR Sutter Yard- AFreitag)5/23/2016 Crossing appears to be in good condition.7/28/2015 Crossing appears in good condition. No noticeable issues to report.11/24/2014 Same as last inspection.6/04/2014 Same as last inspection.11/12/2013 Same as last inspection.6/6/2013 Same as last inspection. FIELD_STRUCT_DESC: 24-inch corrugated metal drainage pipe through the levee, 9.4 feet below the crown. Flap gate on the waterside (WS). Concrete headwalls at both the landside (LS) and the WS toes. [Additional Reference(s): DWR Levee Log, 1990 (HLM 6.56). USACE Sacramento O&M Manual, Unit 515 - Upper Butte Creek - Part No. 1, April 1955, (Station 627+00). USACE As-Built Drawing No. 50-4-2637, Exhibit B, Sheet 3, April 1950]. FS Date: 6/1/2017 1:10:07 PM

Headwall on LS toe.

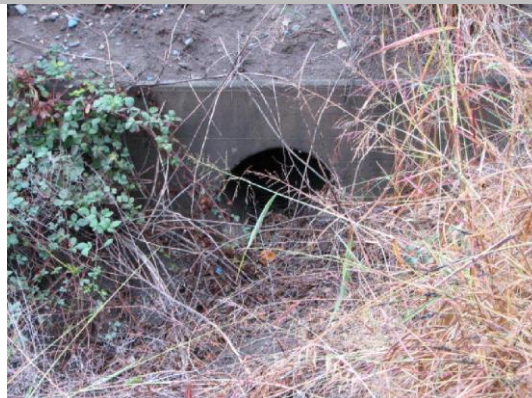
Photo 3 of 3 : UCIP\_FA\_2019\_52049\_68120.jpg

Headwall on LS toe.

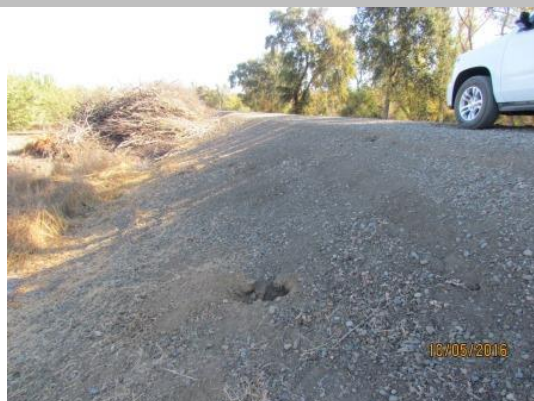
Photo 1 of 2 : FA\_2019\_MA0005\_197\_53\_20190822\_00025.jpg

LM Start	7.74	Rating **	U	Issue No.	53
LM End	7.74	Issue Type +	Ma	Location *	LS
Category	Earthen Levee			GPS Latitude/Longitude	
				Start	End
Item	Animal Control			39.605088 °	39.605088 °
				-121.788569 °	-121.788569 °
DWR ID	DWR_MA0005_02_f_2016_53				
Comment Code					
A3 : No rodents visible, but rodent burrows visible; need to backfill and compact or grout burrows.					
Inspector Comment

View of the rodent holes along the landside slope.

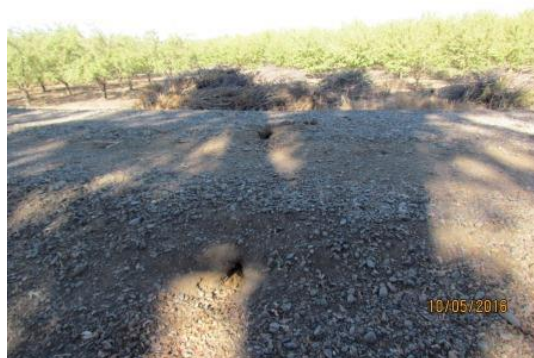
Photo 2 of 2 : FA\_2019\_MA0005\_197\_53\_20190822\_00026.jpg

View of the rodent holes along the crown and waterside slope.

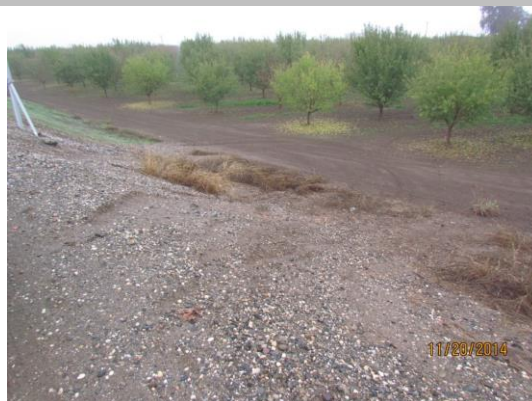
Photo 2 of 2 : FA\_2019\_MA0005\_197\_13\_20190822\_00007.jpg

LM Start	7.98	Rating **	M	Issue No.	13
LM End	7.98	Issue Type +	Ma	Location *	LS
Category	Earthen Levee			GPS Latitude/Longitude	
				Start	End
Item	Slope Stability			39.607710 °	39.607710 °
				-121.785868 °	-121.785868 °
DWR ID	DWR_MA0005_02_s_2012_13				
Comment Code					
S3 : Repair the levee slope damaged by vehicle traffic and prevent access where possible.					
Inspector Comment

View of the vehicle erosion along the landside slope.

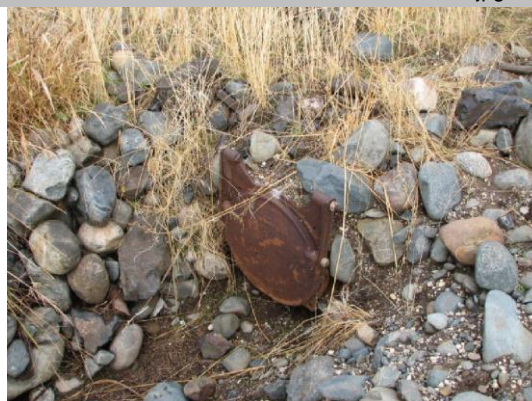
Photo 1 of 2 : UCIP\_FA\_2019\_52052\_68129.jpg

Comment Code						
Inspector Comment						
DS_ID:1656 FS_ID:52052 EP_NO: N/A Repair Type: Non-Urgent Crossing Status: Found UCIP Comments: 5/18/2017 LS inlet is almost completely full of soil. Pipe has been selected to be internally cleaned and inspected as part of the DMP project. (DWR Sutter Yard- AFreitag)11/14/2016 LS inlet almost completely full of soil. (DWR Sutter Yard- AFreitag)5/23/2016 LS end is almost completel full of soil.7/28/2015 Pipe is still over 3/4 full of soil. 11/24/2014 Same as last inspection.6/04/2014 Same as last inspection.11/12/2013 Same as last inspection.6/6/2013 Same as last inspection.10/31/2012 Pipe 3/4 full with soil on LS. FIELD_STRUCT_DESC: 18-inch corrugated metal drainage pipe through the levee at an unknown depth below the crown. Concrete headwall at the landside (LS) toe. Flap gate on the waterside (WS). [Additional Reference(s): USACE Sacramento O&M Manual, Unit 515 - Upper Butte Creek - Part No. 1, April 1955, pipe referenced only in USACE As-Built Drawing No. 50-4-2637, Exhibit B, Sheet 2, April 1950, (Station 550+42)]. FS Date: 6/1/2017 1:15:55 PM

Flap gate at WS toe.

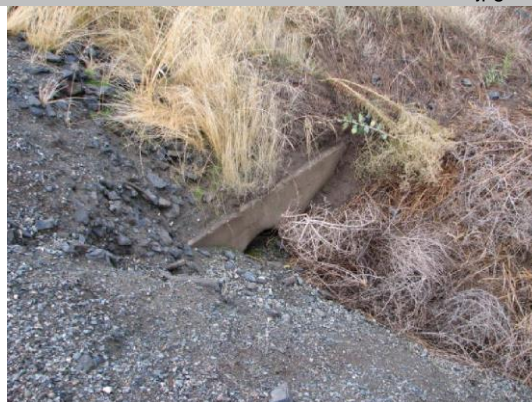
Photo 2 of 2 : UCIP\_FA\_2019\_52052\_68128.jpg

Concrete headwall on LS toe.

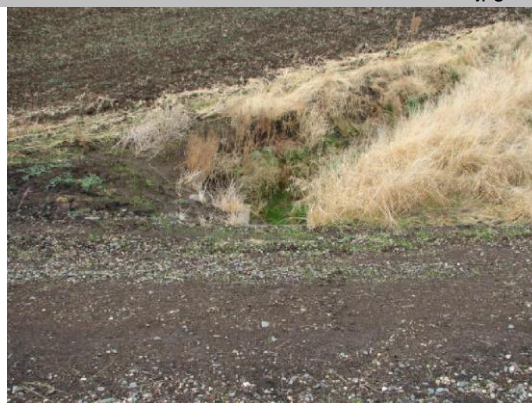
Photo 1 of 3 : UCIP\_FA\_2019\_52059\_68394.jpg

Comment Code						
Inspector Comment						
DS_ID:1662 FS_ID:52059 EP_NO: N/A Repair Type: No Action Needed Crossing Status: Found UCIP Comments: 5/18/2017 Crossing appears to be in good condition. Pipe has been selected to be internally cleaned and inspected as part of the DMP project. (DWR Sutter Yard- AFreitag)11/14/2016 Crossing appears to be in good condition. (DWR Sutter Yard- AFreitag)5/12/2016 Crossing appears to be in good condition.7/30/2015 Crossing is in good condition. No noticeable issues to report.11/24/2014 Same as last inspection.6/4/2014 Same as last inspection.11/13/2013 Same as last inspection..6/6/2013 Same as last inspection. FIELD_STRUCT_DESC: 30-inch corrugated metal drainage pipe through the levee, 16.3 feet below the crown. Flap gate on the waterside (WS). Concrete "U" shaped headwalls on both the landside (LS) and the WS. [Additional Reference(s): DWR Levee Log, 1990 (HLM 8.21). USACE Sacramento O&M Manual, Unit 516 - Upper Butte Creek - Part No. 2, April 1960, (Station 374+90). USACE As-Built Drawing No. 50-4-3367, Exhibit B, Sheet 13, April 1957]. FS Date: 6/1/2017 1:25:58 PM

Concrete inlet on LS toe.

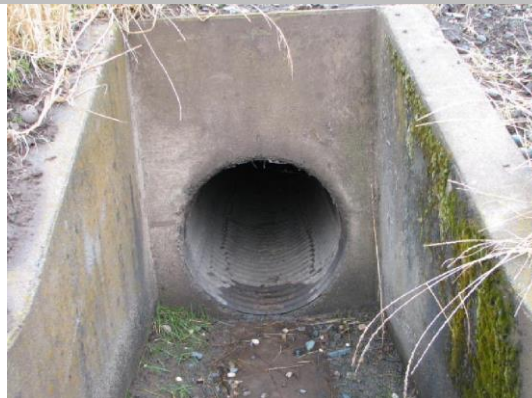
Photo 2 of 3 : UCIP\_FA\_2019\_52059\_68393.jpg

Concrete inlet on LS toe.

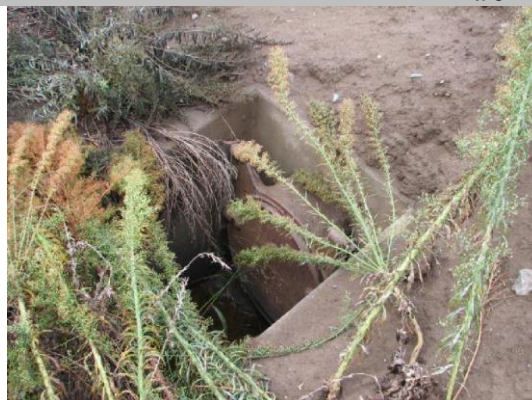
Photo 3 of 3 : UCIP\_FA\_2019\_52059\_68392.jpg

Concrete outlet and flap gate on WS toe.

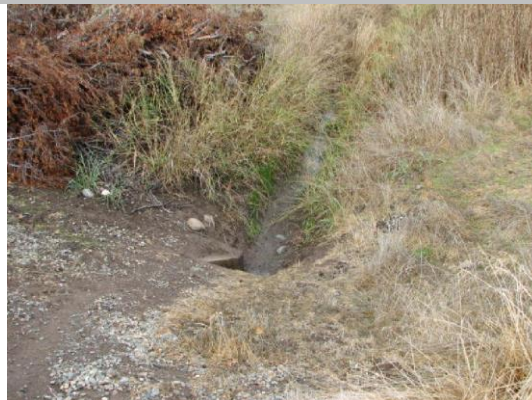
Photo 1 of 3 : UCIP\_FA\_2019\_52061\_68397.jpg

Comment Code						
Inspector Comment						
DS_ID:1663 FS_ID:52061 EP_NO: N/A Repair Type: No Action Needed Crossing Status: Found UCIP Comments: 5/18/2017 Crossing appears to be in good condition. Pipe has been selected to be internally cleaned and inspected as part of the DMP project. (DWR Sutter Yard- AFreitag)11/14/2016 Crossing appears to be in good condition. (DWR Sutter Yard- AFreitag)5/12/2016 Crossing appears to be in good condition.7/30/2015 Crossing appears in good condition. No noticeable issues to report.11/24/2014 Same as last inspection.6/4/2014 Same as last inspection.11/13/2013 Damaged pipe section was dug up and replaced. New WS flapgate with u-shaped wingwall installed on end of pipe.6/6/2013 Same as last inspection. Plans have been made to repair during summer of 2013 before high water season.11/01/2012 Pipe rusted through along bottom at WS outlet. Sink hole over pipe on WS berm. WS headwall eroded eternally around backside of headwall. FIELD_STRUCT_DESC: 24-inch corrugated metal drainage pipe through the levee, 15 feet below the crown. Flap gate on the waterside (WS). Concrete headwalls on both the landside (LS) and the WS. [Additional Reference(s): DWR Levee Log, 1990 (HLM 8.89). USACE Sacramento O&M Manual, Unit 516 - Upper Butte Creek - Part No. 2, April 1960, pipe is only referenced in USACE As-Built Drawing No. 50-4-3367, Exhibit B, Sheet 11, (Station 340+04)]. FS Date: 6/1/2017 1:27:46 PM

Concrete U-shaped headwall on LS toe.

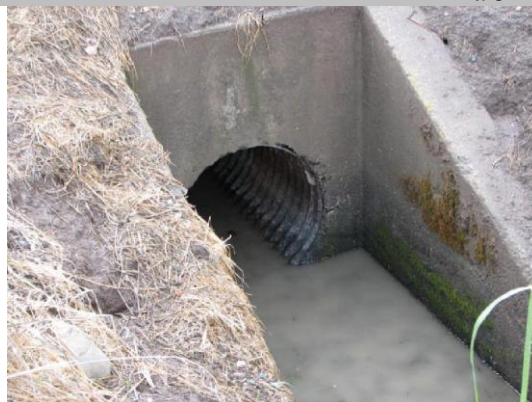
Photo 2 of 3 : UCIP\_FA\_2019\_52061\_68396.jpg

Concrete U-shaped headwall on LS toe.

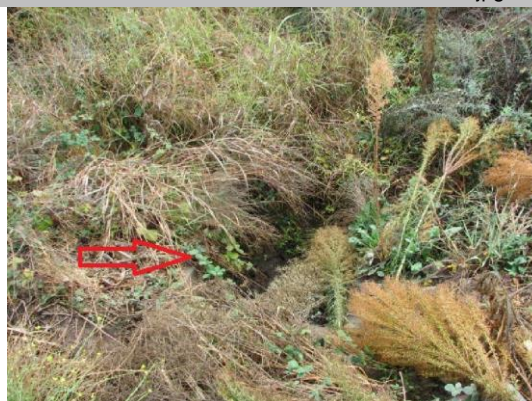
Photo 3 of 3 : UCIP\_FA\_2019\_52061\_68395.jpg

Concrete U shaped outlet and flap gate at WS of Berm.

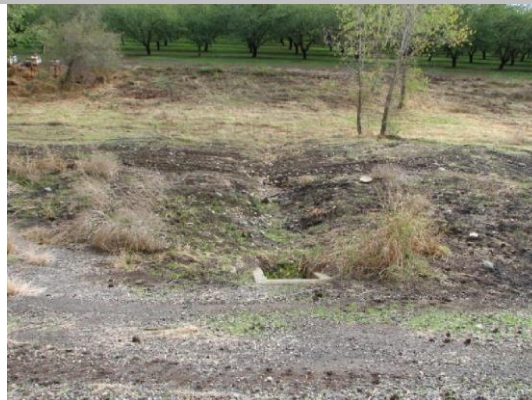
Photo 1 of 3 : UCIP\_FA\_2019\_52062\_68406.jpg

Comment Code					
Inspector Comment					
DS_ID:1664 FS_ID:52062 EP_NO: N/A Repair Type: Non-Urgent Crossing Status: Found UCIP Comments: 5/18/2017 No LS slide gate but not sure its even needed. Pipe has been selected to be internally cleaned and inspected as part of the DMP project. (DWR Sutter Yard- AFreitag)11/14/2016 LS slide gate still missing. Rest of crossing appears in good condition. (DWR Sutter Yard- AFreitag)5/12/2016 LS inlet was unburied. Slide gate still missing7/30/2015 LS inlet is still buried.11/24/2014 Same as last inspection.6/4/2014 Same as last inspection.11/13/2013 Same as last inspection.6/6/2013 Same as last inspection.11/01/2012 LS inlet is buried under soil and covered with brambles. Slide gate missing from LS. FIELD_STRUCT_DESC: 24-inch corrugated metal drainage pipe through the levee, 12 feet below the crown. Flap gate on the waterside (WS). Concrete headwall on the WS. Concrete headwall on the landside (LS), not found. [Additional Reference(s): DWR Levee Log, 1990 (HLM 8.93). USACE Sacramento O&M Manual, Unit 516 - Upper Butte Creek - Part No. 2, April 1960, (Station 338+04). USACE As-Built Drawing No. 50-4-3367, Exhibit B, Sheet 11, April 1957]. FS Date: 6/1/2017 1:29:34 PM

WS outlet and concrete U shaped headwall.

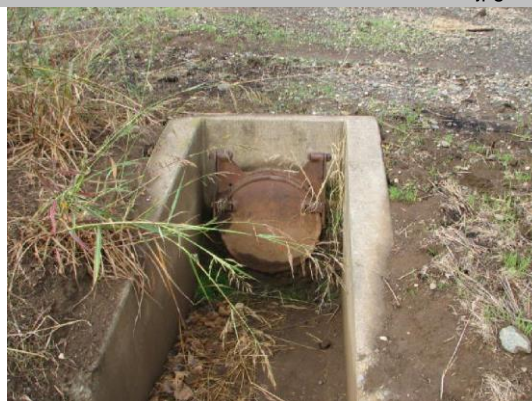
Photo 3 of 3 : UCIP\_FA\_2019\_52062\_68403.jpg

Concrete U shaped headwall and flap gate at WS toe.

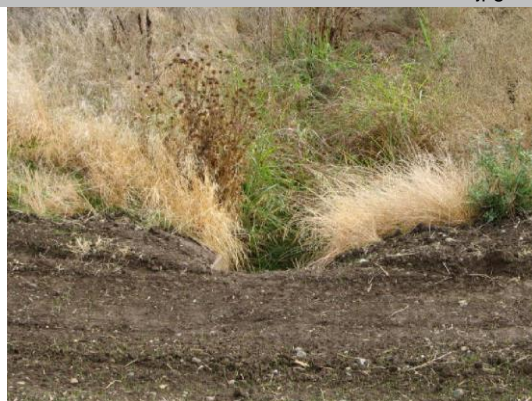
Photo 1 of 3 : UCIP\_FA\_2019\_52063\_68413.jpg

Comment Code					
Inspector Comment					
DS_ID:1665 FS_ID:52063 EP_NO: N/A Repair Type: No Action Needed Crossing Status: Found UCIP Comments: 5/18/2017 Crossing appears to be in good condition. Pipe has been selected to be internally cleaned and inspected as part of the DMP project. (DWR Sutter Yard- A Freitag)11/14/2016 Crossing appears to be in good condition. (DWR Sutter Yard- A Freitag)5/12/2016 Crossing appears to be in good condition.7/30/2015 Crossing appears in good condition. No noticeable issues to report.11/24/2014 Same as last inspection.6/4/2014 Same as last inspection.11/13/2013 Same as last inspection.6/6/2013 Same as last inspection. FIELD_STRUCT_DESC: 24-inch corrugated metal drainage pipe through the levee, 11.3 feet below the crown. Flap gate on the waterside (WS). Concrete headwalls on both the landside (LS) and the WS. [Additional Reference(s): DWR Levee Log, 1990 (HLM 9.25). USACE Sacramento O&M Manual, Unit 516 - Upper Butte Creek - Part No. 2, April 1960, (Station 321+20)]. FS Date: 6/1/2017 1:32:51 PM

Concrete U shaped headwall and flap gate on WS toe.

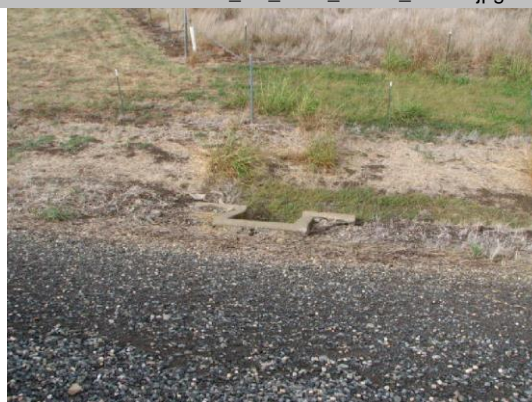
Photo 2 of 3 : UCIP\_FA\_2019\_52063\_68412.jpg

Concrete U shaped headwall on LS toe.

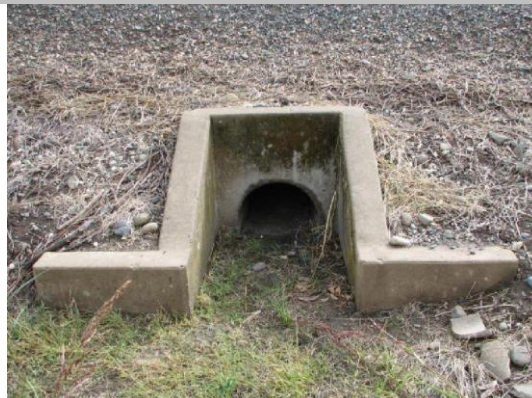
Photo 3 of 3 : UCIP\_FA\_2019\_52063\_68411.jpg

Concrete U shaped headwall on LS toe.

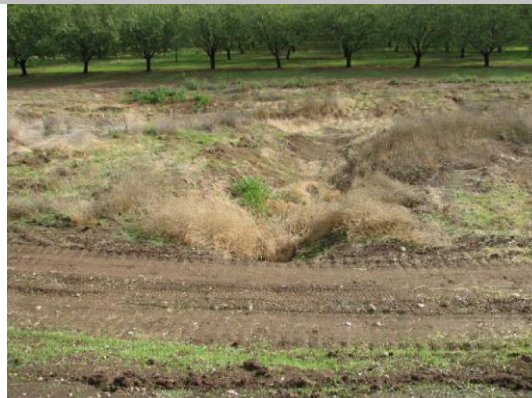
Photo 1 of 3 : UCIP\_FA\_2019\_52064\_68417.jpg

Comment Code					
Inspector Comment					
DS_ID:1666 FS_ID:52064 EP_NO: N/A Repair Type: Non-Urgent Crossing Status: Found UCIP Comments: 5/18/2017 LS inlet half full of soil and WS flap gate half buried by sediment. Pipe has been selected to be internally cleaned and inspected as part of the DMP project. (DWR Sutter Yard-AFreitag)11/14/2016 LS pipe inlet is half full of soil. WS flap gate shut but half buried by sediment. (DWR Sutter Yard-AFreitag)5/12/2016 Pipe is half full of soil.7/30/2015 Pipe is 1/4 to 1/2 full of soil still.11/24/2014 Same as last inspection.6/4/2014 Same as last inspection.11/13/2013 Same as last inspection.6/6/2013 Same as last inspection.11/01/2012 Pipe 1/2 filled with soil. FIELD_STRUCT_DESC: 24-inch corrugated metal drainage pipe through the levee, 11.2 feet below the crown. Flap gate on the waterside (WS). Concrete "U" shaped headwalls on both the landside (LS) and the WS. [Additional Reference(s): DWR Levee Log, 1990 (HLM 9.57). USACE Sacramento O&M Manual, Unit 516 - Upper Butte Creek - Part No. 2, April 1960, (Station 304+10). USACE As-Built Drawing No. 50-4-3367, Exhibit B, Sheet 3, April 1957]. FS Date: 6/1/2017 1:34:12 PM

View of outlet looking toward WS toe.

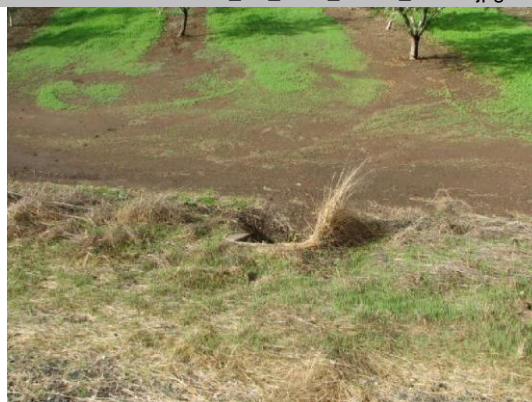
Photo 2 of 3 : UCIP\_FA\_2019\_52064\_68416.jpg

View of inlet on LS toe.

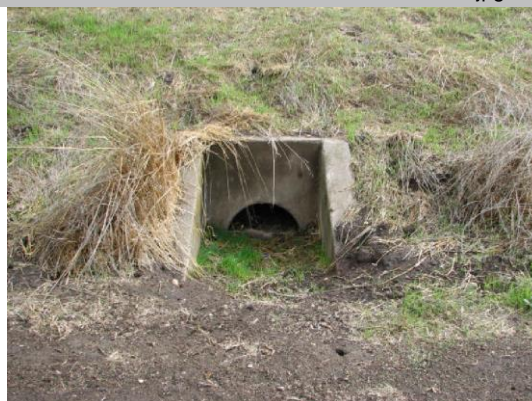
Photo 3 of 3 : UCIP\_FA\_2019\_52064\_68415.jpg

Concrete U-shaped headwall on LS toe.

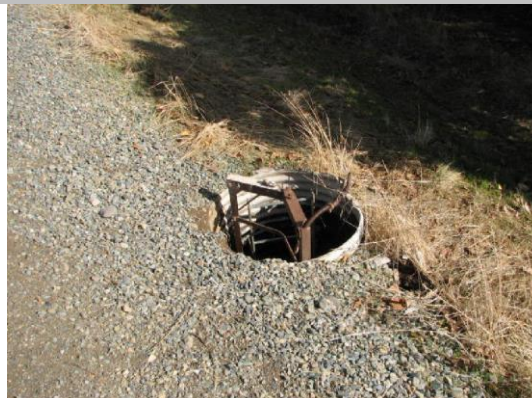
Photo 1 of 3 : UCIP\_FA\_2019\_54048\_68465.jpg

Comment Code						
Inspector Comment						
DS_ID:1673 FS_ID:54048 EP_NO: N/A Repair Type: Non-Urgent Crossing Status: Found UCIP Comments: 05/23/2019 (O. Magana - DWR UCIP)05/18/2017 Abandoned- needs to be done properly. Pipe has been selected to be internally cleaned and inspected as part of the DMP project. (DWR Sutter Yard- A Freitag)11/14/2016 Abandoned- needs a cover for standpipe. (DWR Sutter Yard- A Freitag)05/11/2016 Abandoned crossing. Needs a cover for the WS riser.08/03/2015 Crossing appears abandoned. Only the slide gate inside riser on the WS shoulder could be found. Riser needs a cover made for it.11/24/2014 Same as last inspection.06/04/2014 Same as last inspection.11/13/2013 Slide gate top and stem were repaired to make gate operational.06/06/2013 New slidegate is planned to be installed during summer of 2013.11/01/2012 Slide gate on WS shoulder bent and damaged (inoperable) Pipe appears abandoned. FIELD_STRUCT_DESC: *ABANDONED* 24-inch corrugated metal drainage pipe through the levee, 14 feet below the crown. Slide gate in a corrugated metal riser on the waterside (WS) slope. [Additional Reference(s): DWR Levee Log, 1990 (HLM 12.98). USACE Sacramento O&M Manual, Unit 516 - Upper Butte Creek - Part No. 2, April 1960, (Station 126+91)]. FS Date: 5/23/2019 5:20:37 PM

Broken slide gate in CM riser on WS slope.

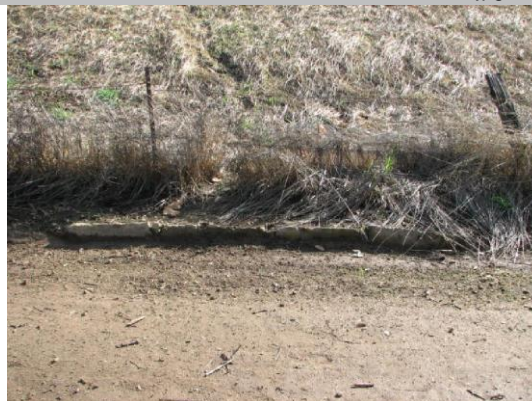
Photo 2 of 3 : UCIP\_FA\_2019\_54048\_68464.jpg

Abandoned headwall on LS toe.

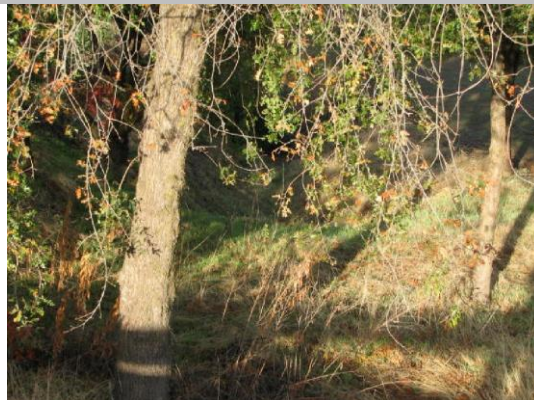
Photo 1 of 3 : UCIP\_FA\_2019\_52083\_68531.jpg

Comment Code					
Inspector Comment					
DS_ID:1679					
FS_ID:52083					
EP_NO: N/A					
Repair Type: No Action Needed					
Crossing Status: Found					
UCIP Comments: 5/18/2017 Crossing appears to be in good condition.					
Pipe has been selected to be internally cleaned and inspected as part					
of the DMP project. (DWR Sutter Yard- A Freitag)11/14/2016					
Crossing appears to be in good condition. (DWR Sutter Yard-					
A Freitag)5/11/2016 Crossing appears to be in good					
condition.8/3/2015 Crossing appears in good condition. No					
noticeable issues to report.11/25/2014 Same as last					
inspection.6/4/2014 Same as last inspection.11/13/2013 Same as					
last inspection.6/6/2013 Same as last inspection.					
FIELD_STRUCT_DESC: 24-inch corrugated metal drainage pipe					
through the levee, 14.5 feet below the crown. Concrete "U" shaped					
headwall on the waterside (WS). Flap gate on the WS. [Additional

Inlet relocated after bridge replacement away from LS toe.

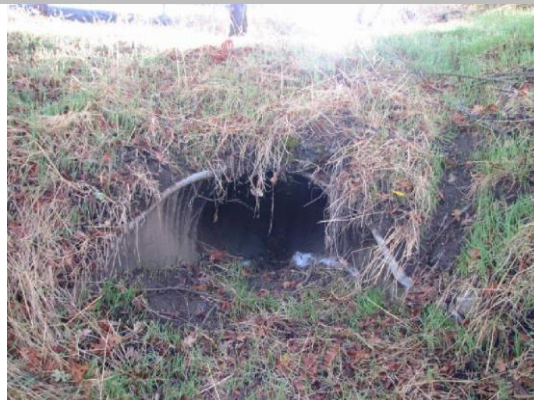
Photo 2 of 3 : UCIP\_FA\_2019\_52083\_68530.jpg

Inlet 50-feet NW of levee crown.

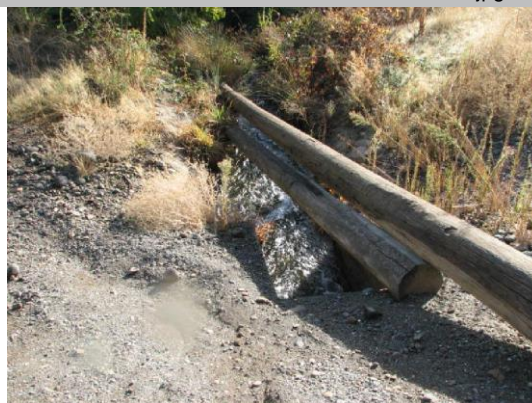
Photo 1 of 3 : UCIP\_FA\_2019\_54049\_68544.jpg

Comment Code					
Inspector Comment					
DS_ID:1682 FS_ID:54049 EP_NO: N/A Repair Type: No Action Needed Crossing Status: Found UCIP Comments: 05/23/2019 (O. Magana - DWR UCIP)05/18/2017 Crossing appears to be in good condition. Pipe has been selected to be internally cleaned and inspected as part of the DMP project. (DWR Sutter Yard- AFreitag)11/14/2016 Crossing appears to be in good condition. (DWR Sutter Yard- AFreitag)05/11/2016 Crossing appears to be in good condition.08/03/2015 Crossing appears in good condition. No noticeable issues to report.11/25/2014 Same as last inspection.06/04/2014 Same as last inspection.11/13/2013 Same as last inspection.06/06/2013 Same as last inspection. FIELD_STRUCT_DESC: 24-inch corrugated metal drainage pipe through the levee, 7.2 feet below the crown. Concrete "U" shaped headwall and grouted spillway on the waterside (WS). Slide gate in a 48-inch concrete standpipe on the landside (LS). Flap gate on the WS. [Additional Reference(s): DWR Levee Log, 1990 (HLM 14.68). USACE Sacramento O&M Manual, Unit 516 - Upper Butte Creek - Part No. 2, April 1960, (Station 37+10)]. FS Date: 5/23/2019 5:21:51 PM

Outlet at U-shaped headwall on WS toe.

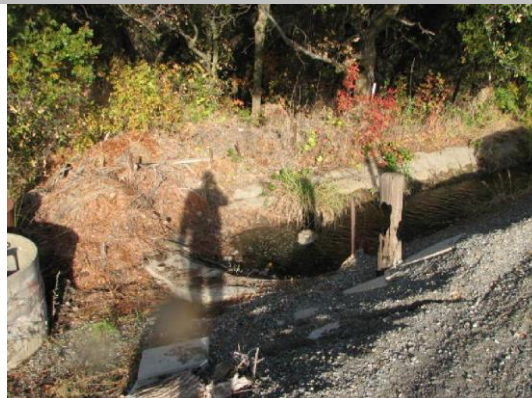
Photo 2 of 3 : UCIP\_FA\_2019\_54049\_68543.jpg

Concrete lined channel on LS toe.

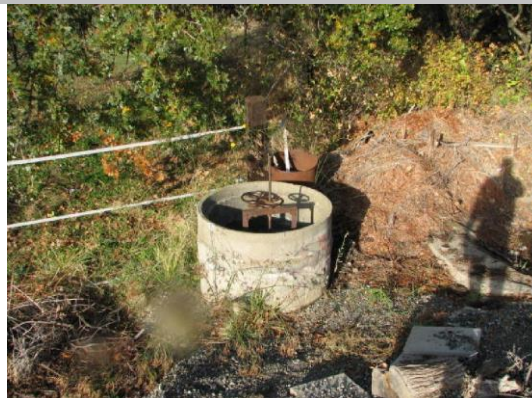
Photo 3 of 3 : UCIP\_FA\_2019\_54049\_68542.jpg

Concrete standpipe and slide gate on LS toe.

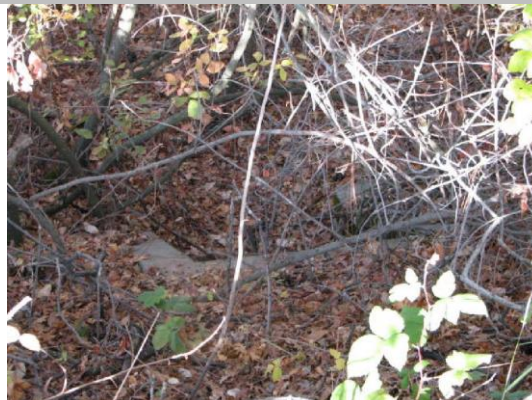
Photo 1 of 2 : UCIP\_FA\_2019\_52087\_68541.jpg

Comment Code						
Inspector Comment						
DS_ID:1683 FS_ID:52087 EP_NO: N/A Repair Type: Non-Urgent Crossing Status: Found UCIP Comments: 5/18/2017 WS appears to be in good condition. LS inlet is across a ditch and inaccessible for inspection due to dense vegetation and being down a very steep slope. Pipe has been selected to be internally cleaned and inspected as part of the DMP project. (DWR Sutter Yard- A Freitag)11/14/2016 Crossing appears to be in good condition. (DWR Sutter Yard- A Freitag)5/11/2016 Crossing appears to be in good condition.8/3/2015 Crossing appears in good condition. No noticeable issues to report.6/6/2013 Same as last inspection.11/13/2013 Same as last inspection.6/4/2014 Same as last inspection.11/25/2014 Same as last inspection. FIELD_STRUCT_DESC: 24-inch corrugated metal drainage pipe through the levee, 14.3 feet below the crown. Concrete "U" headwalls on both the landside (LS) and the waterside (WS). Flap gate on the WS. Inlet downhill from a concrete lined channel at the low point on the LS toe. [Additional Reference(s): DWR Levee Log, 1990 (HLM 14.69). USACE Sacramento O&M Manual, Unit 516 - Upper Butte Creek - Part No. 2, April 1960, (Station 36+85)]. FS Date: 6/1/2017 2:14:24 PM

Inlet at LS toe.

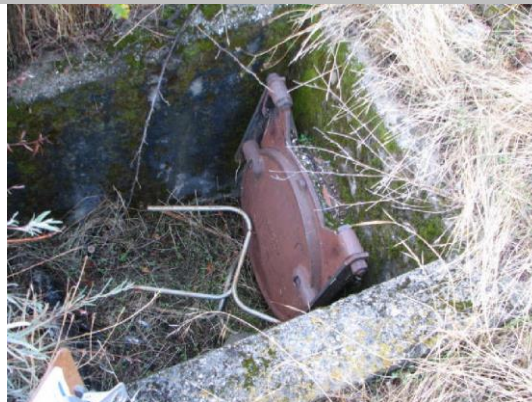
Photo 2 of 2 : UCIP\_FA\_2019\_52087\_68540.jpg

Outlet at WS toe with flap gate and concrete U-shaped headwall.

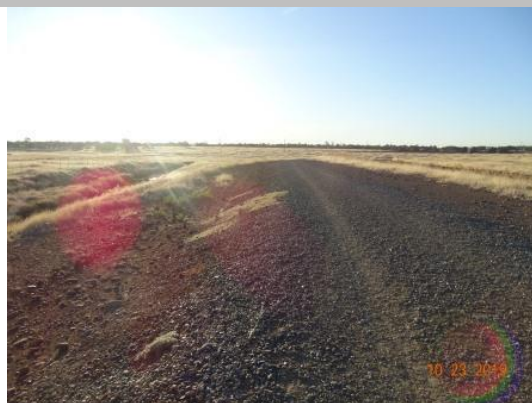
Photo 1 of 1 : FA\_2019\_MA0005\_198\_1\_20191028\_00001.jpg

LM Start	0.55	Rating **	A	Issue No.	1
LM End	0.55	Issue Type +	Ma	Location *	WS
Category	Earthen Levee			GPS Latitude/Longitude	
				Start	End
Item	Vegetation			39.724271°	39.724271°
				-121.781058°	-121.781058°
DWR ID	DWR_MA0005_03_f_2019_1				
Comment Code					
V1 : Control annual grass and weeds on the levee slopes and easements.					
Inspector Comment					
Vegetation is well maintained on both landside and waterside slopes.

View of well-maintained waterside slope, free of vegetation. Fall 2019.
